**SUBJECT: TREE REPLACEMENT
MEMORIAL, ISHAM & RAYMOND ROAD
SPECIAL DEVELOPMENT DISTRICT ADMINISTRATIVE
AMENDMENT (SDD #113-R1-16)**

Re: Tree replacement in Blue Back Square

West Hartford Town Center Street Trees Assessment and Recommendations

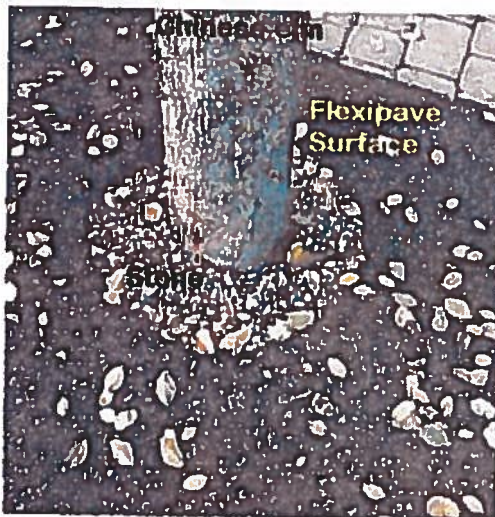
Photo # 1

Root collar investigation reveals planting depth in London Plane and Chinese elm too deep.

Photograph # 1 above showing surface texture with no visible root flare at surface.
Photograph # 2 showing poor condition, limited foliage and healthy buds.

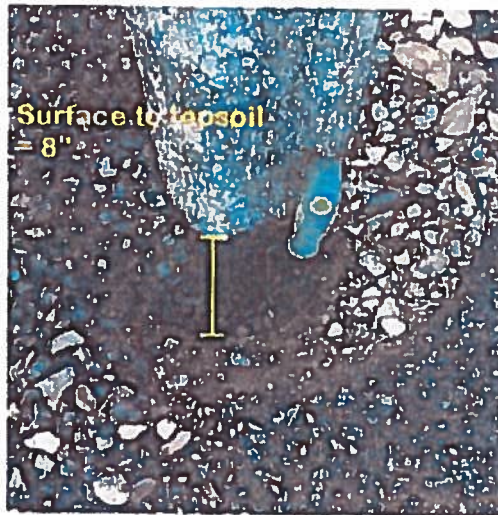
Photo # 3 Surface to topsoil 8"

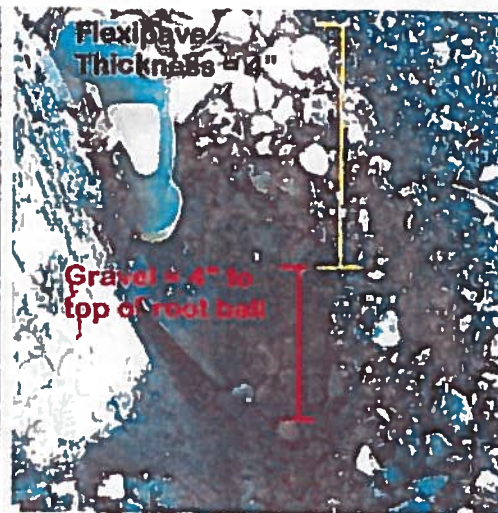
Photo # 4 Flexipave thickness 4"; Gravel Thickness 4 "

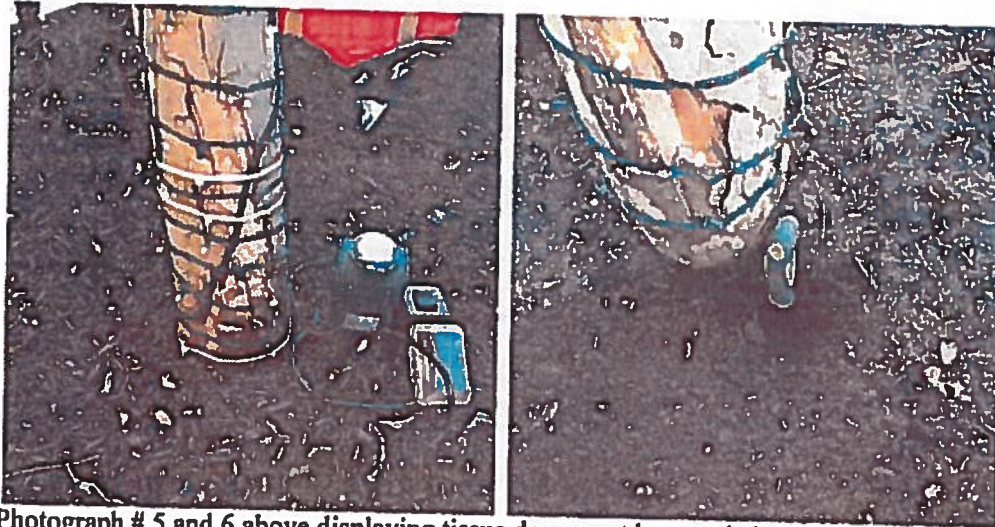
Photograph # 5 and 6 above displaying tissue damage at base and close proximity of electrical infrastructure.
